**AGENDA**  
**TOWN OF PINCHER CREEK**  
**COMMITTEE OF THE WHOLE**  
Wednesday, May 5, 2021 AT 9:00 A.M.  
962 St. John Avenue, Council Chambers  
[Virtual via Zoom](#)

# TOWN OF PINCHER CREEK

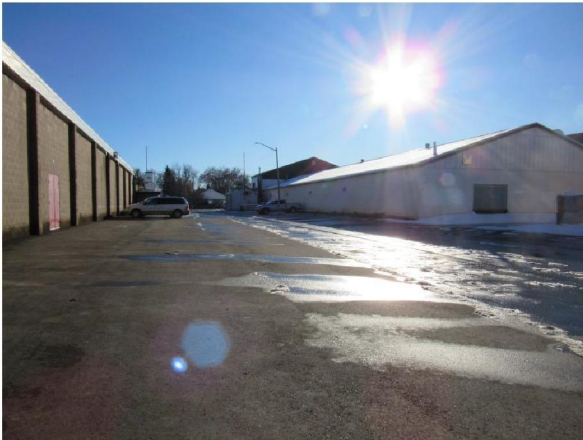
Photo #A1: Site parking lot.

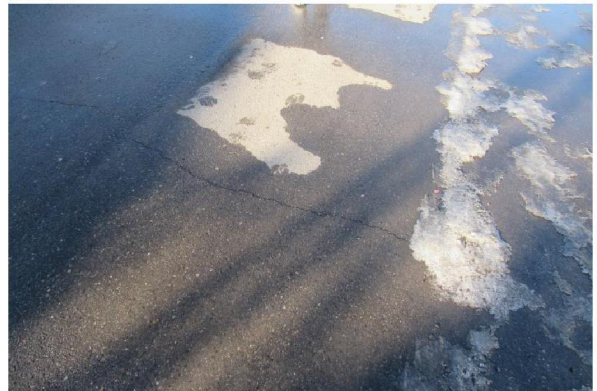
Photo #A2: Asphalt Cracks in parking lot.

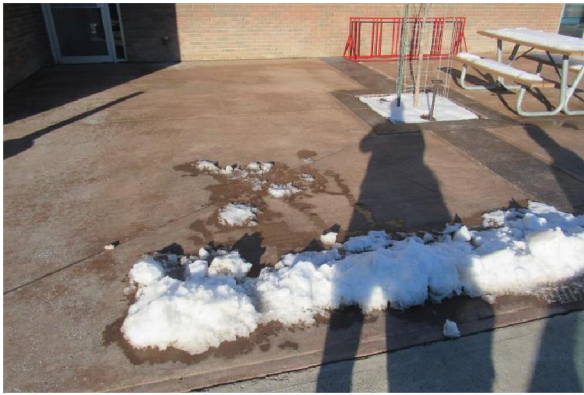
**Photo #A3:** Concrete pad walkway near front entrance.

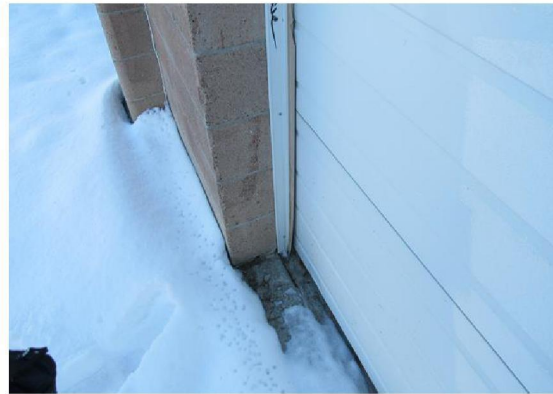
**Photo #A8:** Improper sealant (weather stripping) shown at the overhead door on the rear of the building.

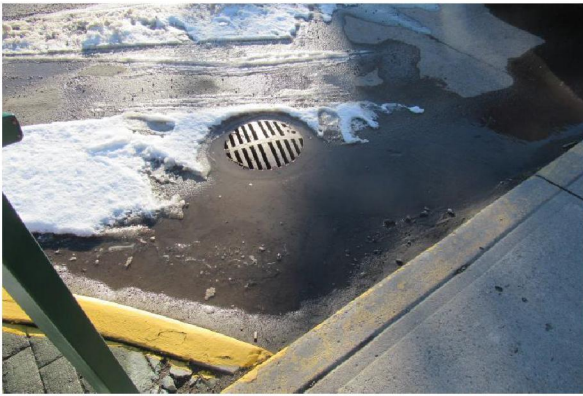
**Photo #A9:** Storm sewer in street near entry drive.

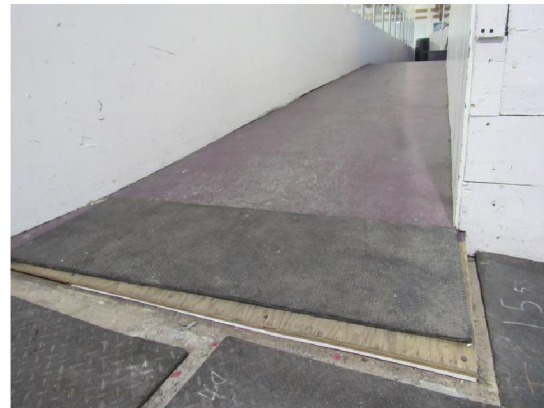
**Photo #A18:** Tripping hazard and lack of handrails on barrier free ramp near bleachers.

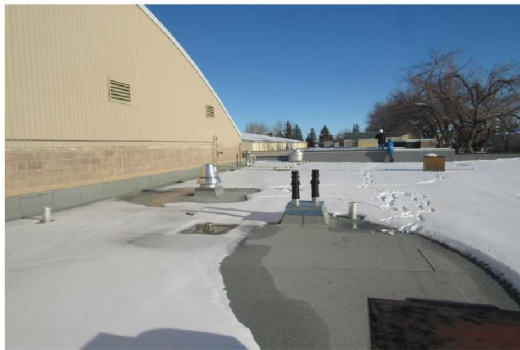
**Photo #A19:** SBS flat roof system.

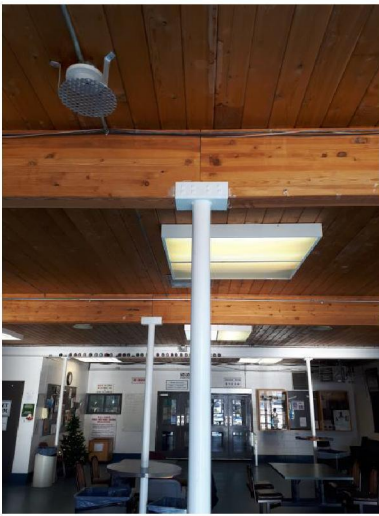
**Photo #S1:** Wood Beam-Steel Column in Lobby.

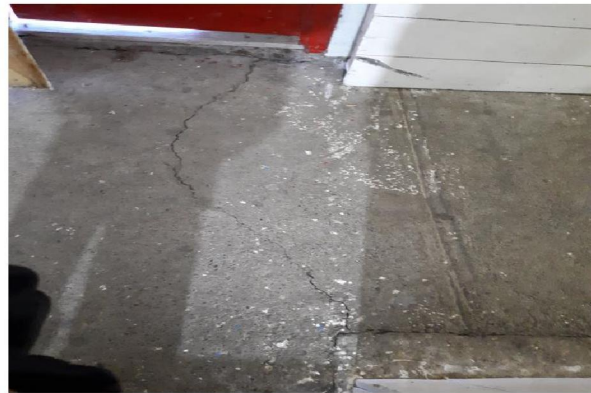
**Photo #S2:** Crack in slab-on-grade under the seating area.

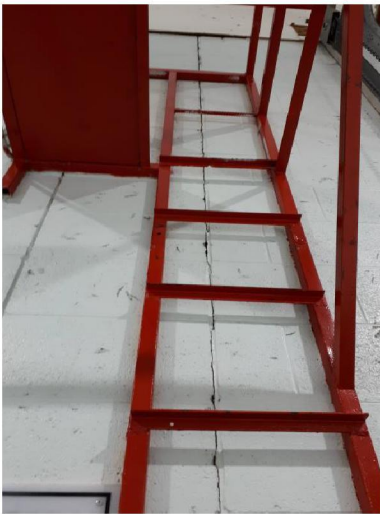
**Photo #S3:** Vertical joint separation in CMU wall.

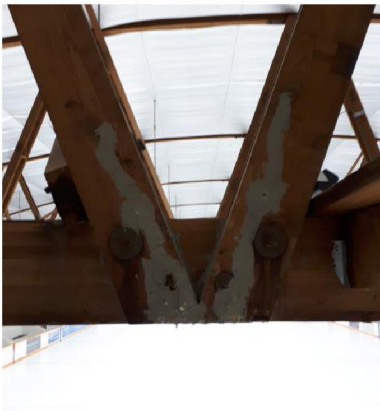
**Photo #S5:** Repaired cracks in wood members of trusses.

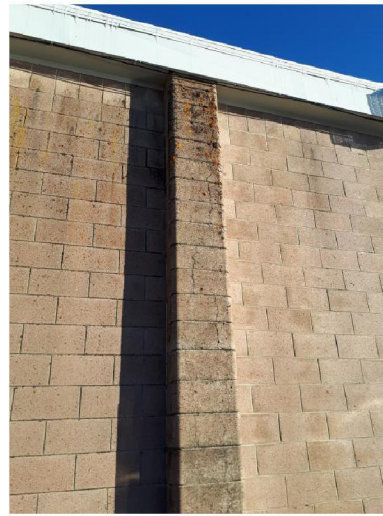
**Photo #S6:** Cracks in pier of the exterior CMU wall.

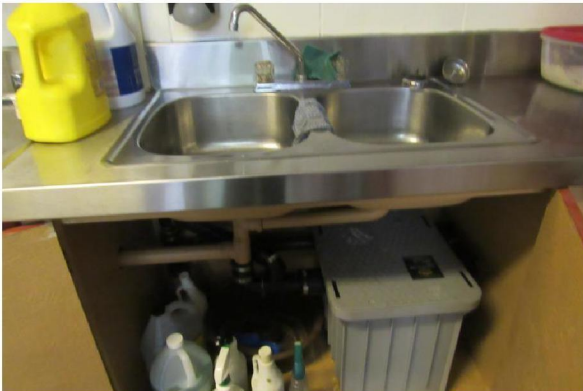
**Photo #M1:** Stainless steel double basin sinks in canteen.

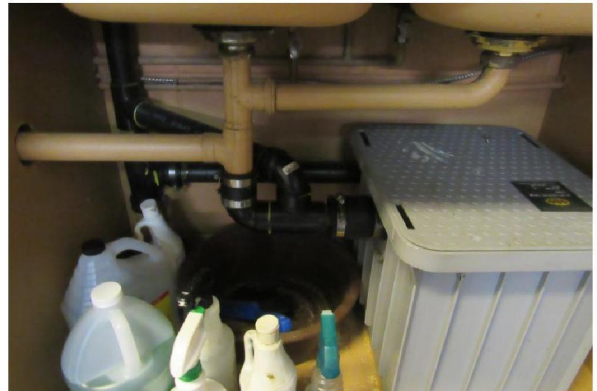
**Photo #M2:** Grease trap and piping.

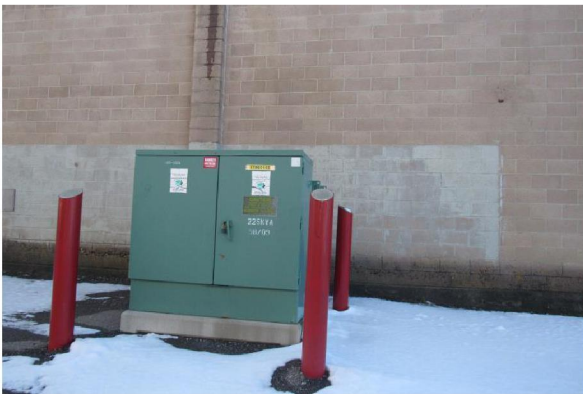
**Photo #E1:** On site electrical transformer.

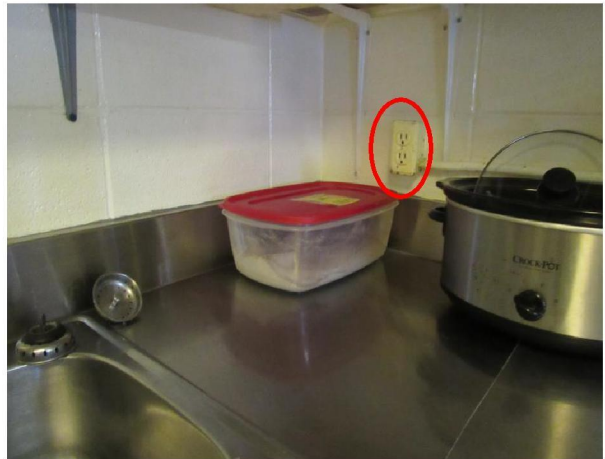
**Photo #E6:** Non GFCI receptacle found within 1 meter of a sink.

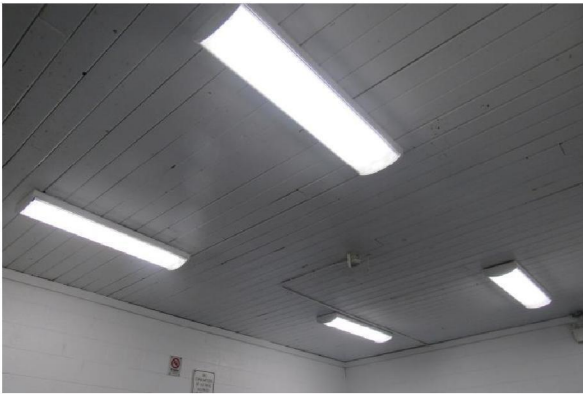
**Photo #E7:** Ceiling mounted fluorescent lights.

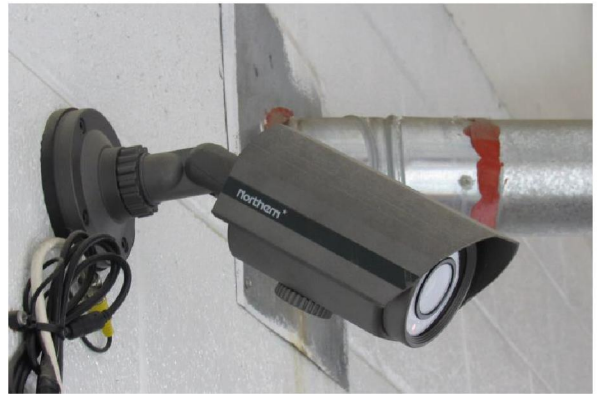
**Photo #E10:** Northern surveillance camera
